Manhole Inspection Summary

Manhole # S65G__019MH

Insp Date: **3/14/08 10:37 AM**

Location Address: **332 El Rino St.**

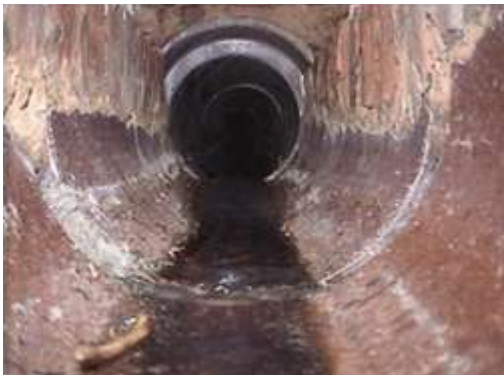
Defect 1

Condition: ☐ Sound ☒ **Cracked** ☐ Root Intrusion ☐ Deteriorated ☐ Leaks ☐ Debris

Crack/ broken channel 3:00-9:00

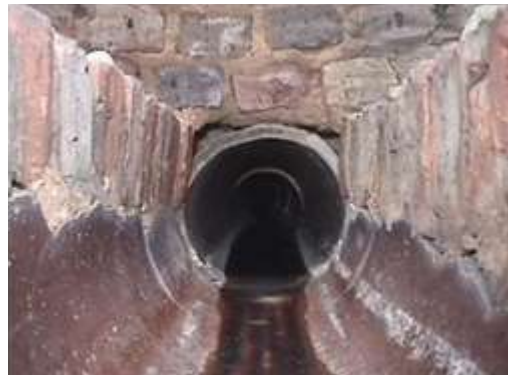
Defect 2

Cracked pipe seal 10:00 - 3:00. Incoming 6 O'Clock.

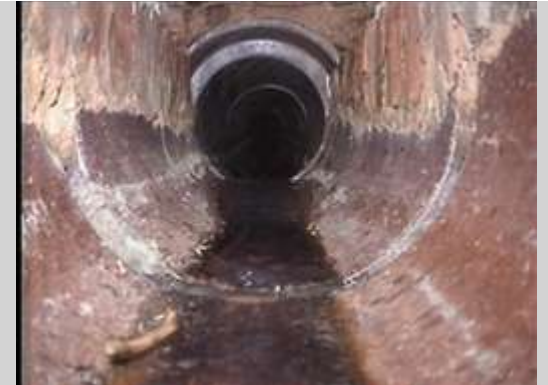
12 O'Clock Outflow

8 in. Circular Gravity Sewer
Pipe Out @ 12 O'Clock

Pipe Height: **8.4** (in.) Rod and Bar (Angled)
Pipe Material: **Clay** ☐ Pipe Lined
Invert Depth: **7.42** (ft.) Flow Characteristics: **Slow**
Deposits: ☒ None ☐ Mud ☐ Sludge ☐ Debris ☐ Grease
Silt Depth: (in.) Deposits Extent:
Infiltration: **None** Pipe Seal Cond: **Sound**

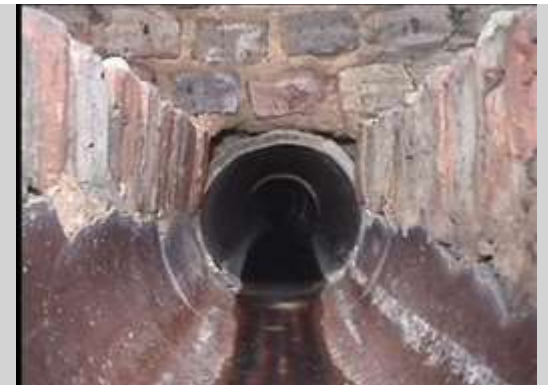
6 O'Clock Inflow

8 in. Circular Gravity Sewer
Pipe In @ 6 O'Clock

Pipe Height: **8.4** (in.) Rod and Bar (Angled)
Pipe Material: **Clay** ☐ Pipe Lined
Invert Depth: **7.33** (ft.) Flow Characteristics: **Slow**
Deposits: ☒ None ☐ Mud ☐ Sludge ☐ Debris ☐ Grease
Silt Depth: (in.) Deposits Extent:
Infiltration: **Evidence** Pipe Seal Cond: **Cracked**
